OWNER: Brendan Cunningham. 4 Cherry Tree Close, NN14 2SF

# Extra Service/Repair/Upgrade :

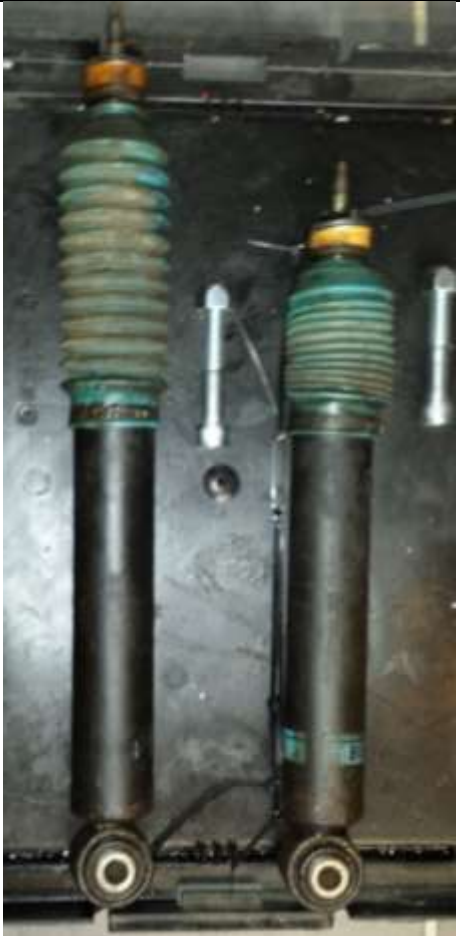
Date	Miles	Notes	
24/04/2015	39330	Remove all 4 wheels, check tyres and brakes. Regrease wheel mounting and fit new wheel centre caps.	
31/07/2015	39504	Front anti-roll bar drop-links. Rubber dry, split and perished. New bushes and new AM cup washers fitted. All related parts waxoyled.	
04/08/2015	39556	<p>Slight knock from RH front end. Removed shock absorbers and checked operation and bushes. Function of SA fine, and all bushes in good condition apart from rusted cup washers at top. Fitted new top mounting kits as known weakness. Body mounting plate front top mounts showing early signs of surface rust as expected so cleaned and Waxoyled. All components inspected, surface rust removed and thoroughly Waxoyled. New high tensile bolts and nuts for bottom mount.</p>

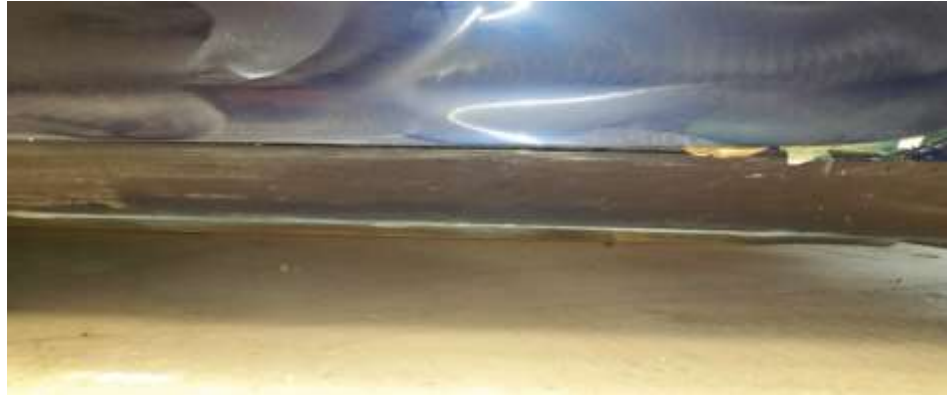
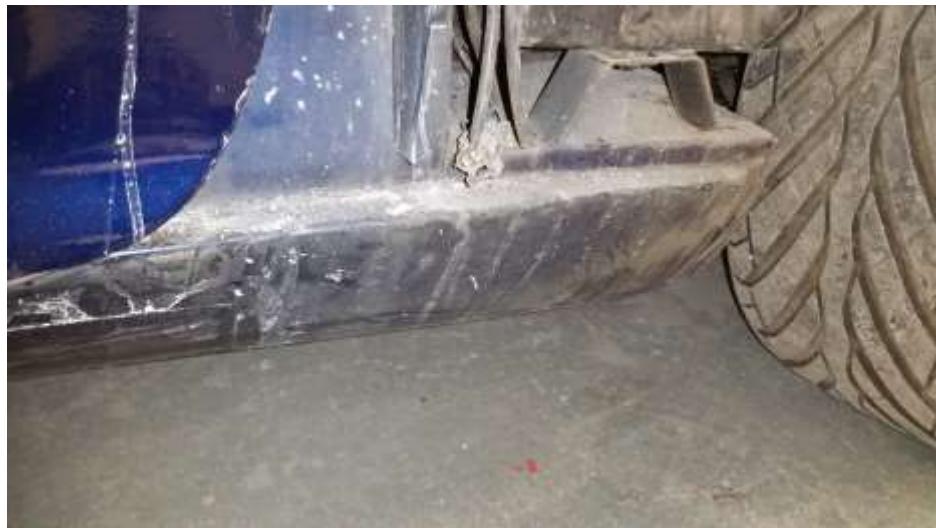
24/05/2016 To	40524	<p>Taken to Paint FX in Kettering for full respray. This was decided upon due to several small but annoying blemishes and a poor finish on the nose cone following a pre-purchase stone chip removal respray. There was also slight bubbling around the front and rear screens. The owner of Paint FX, Tim, was happy for me to work alongside his team. The car was fully stripped including removal of front and rear sections, side skirts, lights, handles, both front and rear screens. Once stripped down, the state of the bodywork could be assessed. Having been warned about rust on these cars I was very pleased to find that there was no evidence of rust at all other than minor surface blemishes on some edges.</p>

*(Sill shots showing zero rust – pre Waxoyl).*

When reassembling the car it was decided for longevity to use copious amounts of Waxoyl on “under” surfaces rather than aim for a concours paint finish.

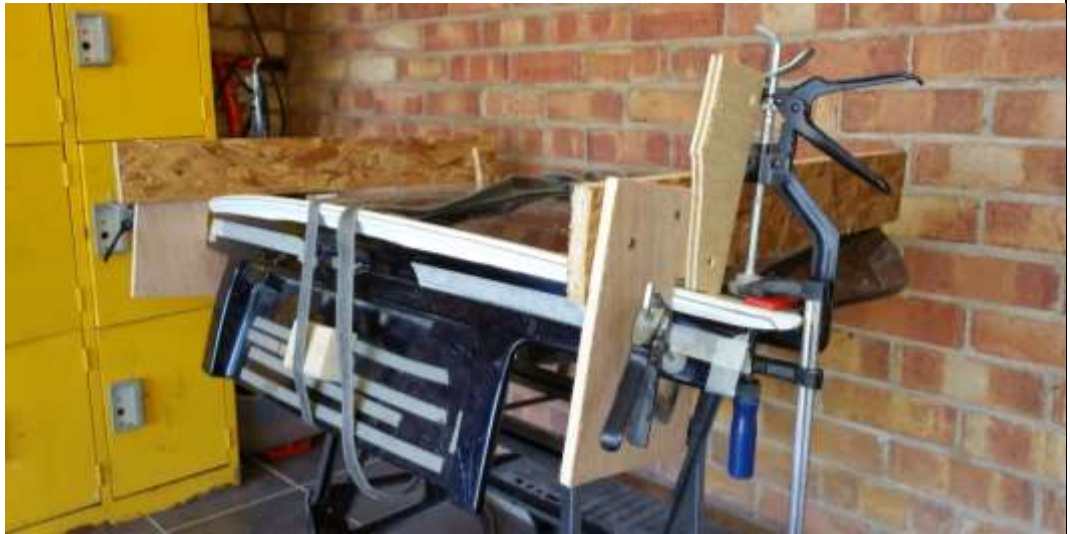
<p><i>(Shows jig to reshape and twist pre-cut spoiler. New GRP core to hold shape).</i>            The spoiler is attached using high quality tape and so can be removed if desired.</p>

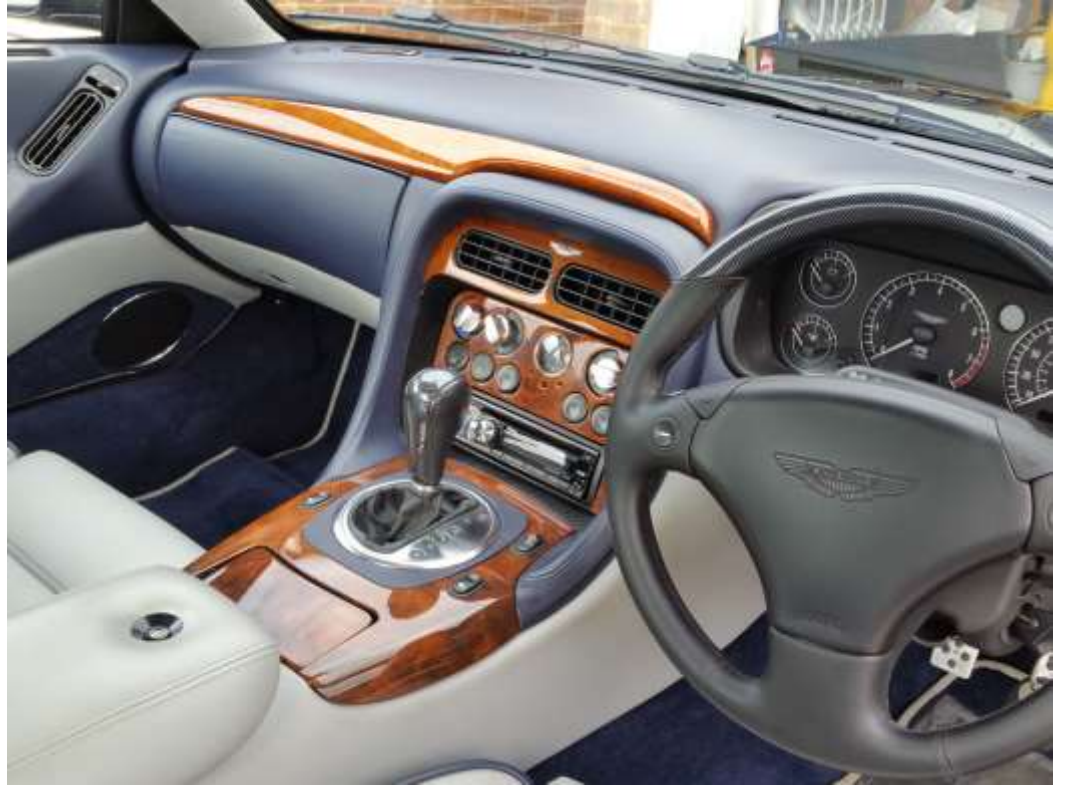
steering wheel fitted – simple plug and play. Genuine Touchtronic instrument binnacle fitted. This was assembled from a combination of parts from the original unit and the Touchtronic unit to ensure correct odometer reading is shown. Audi TT selector surround fitted with associated DIY trimming. There were some wiring changes which have been added to my printed workshop manual.
