OWNER: Brendan Cunningham. 4 Cherry Tree Close, NN14 2SF

Extra Service/Repair/Upgrade :

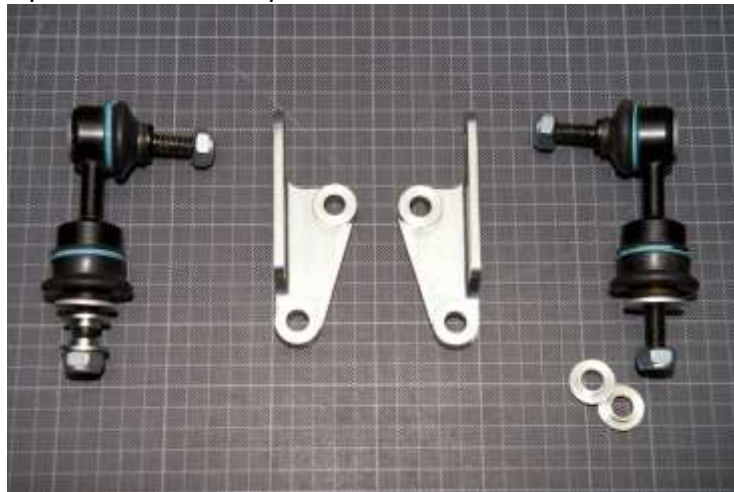
Front: Shock absorbers (inc new bushes) rebuilt by Bilstein in Leicester.
New top and bottom ball joints (Lemforder OEM spec).
New upper wishbone bushes.
New roll bar mounting bushes.
Upated roll bar drop links fitted.
