OWNER: Brendan Cunningham. 4 Cherry Tree Close, NN14 2SF

# Extra Service/Repair/Upgrade :

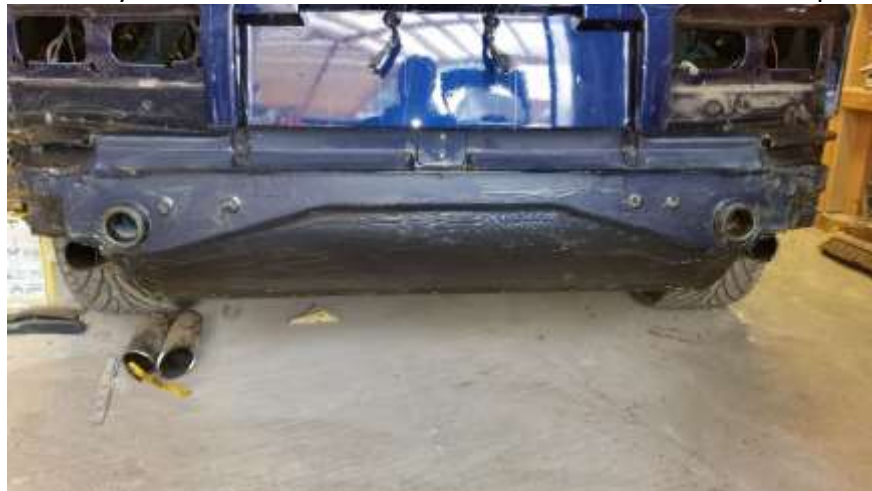
The bubbling in two places around the screens turned out to be caused by previous glass replacement and not more serious rot. The bubbling was purely a surface blemish (Note – I was present for glass refit and great care was taken to ensure no repeat).

The tray below the valance in front of the windscreen was totally rust free. The respray involved extra thick lacquer and subsequent flatting and polishing to achieve the desired finish.

When reassembling the car it was decided for longevity to use copious amounts of Waxoyl on “under” surfaces rather than aim for a concours paint finish.
