OWNER: Brendan Cunningham. 4 Cherry Tree Close, NN14 2SF

Extra Service/Repair/Upgrade :

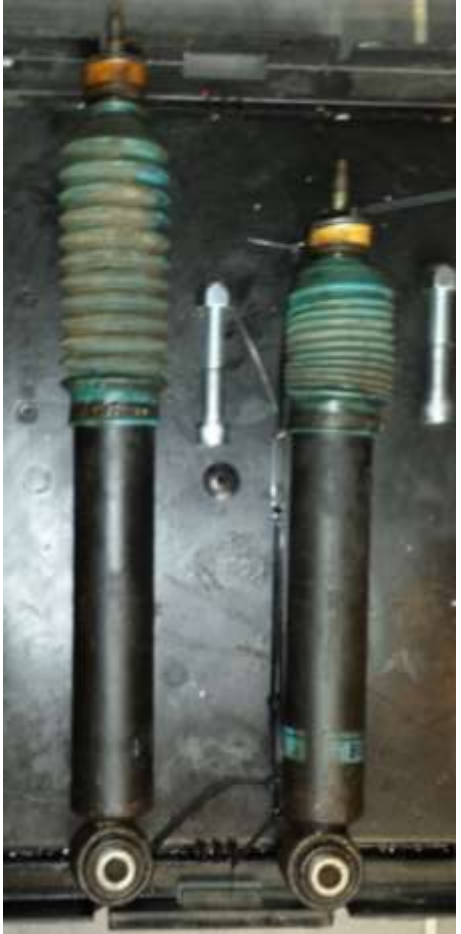
Date	Miles	Notes	
April 2015	39330	Remove all 4 wheels, check tyres and brakes. Regrease wheel mounting and fit new wheel centre caps.	
July 2015	39504	Front anti-roll bar drop-links. Rubber dry, split and perished. New bushes and new AM cup washers fitted. All related parts waxoyled.	
August 2015	39556	<p>Slight knock from RH front end. Removed shock absorbers and checked operation and bushes. Function of SA appeared fine, and all bushes in good condition apart from rusted cup washers at top. Fitted new top mounting kits as known weakness.</p> <p>Body mounting plate front top mounts showing early signs of surface rust as expected so cleaned and Waxoyled. All components inspected, surface rust removed and thoroughly Waxoyled. New high tensile bolts and nuts for bottom mount.</p>

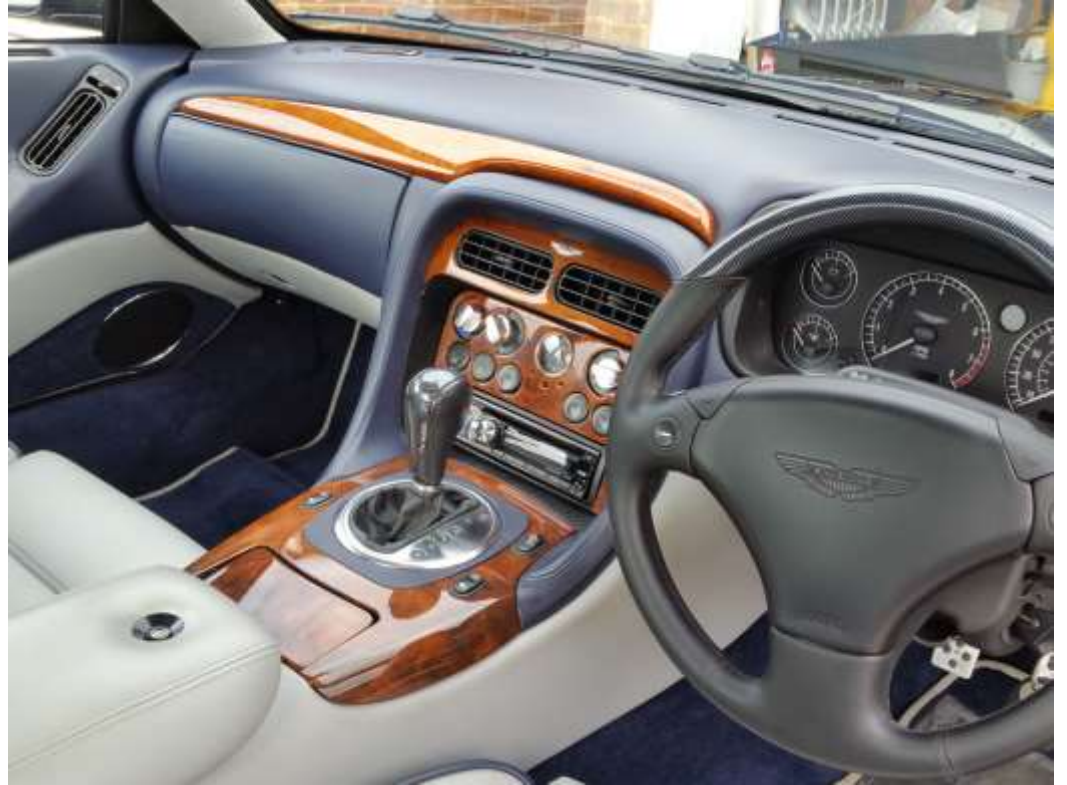
steering wheel fitted – simple plug and play. Genuine Touchtronic instrument binnacle fitted. This was assembled from a combination of parts from the original unit and the Touchtronic unit to ensure correct odometer reading is shown. Audi TT selector surround fitted with associated DIY trimming. There were some wiring changes which have been added to my printed workshop manual.
